Multiple shocks after upgrade of an implantable cardioverter-defibrillator to a cardiac resynchronization therapy-defibrillator device

Gregory M. Francisco, Saumya Sharma, Anne H. Dougherty, Bharat K. Kantharia

Division of Cardiology, University of Texas, Medical School at Houston, Houston, Texas, USA

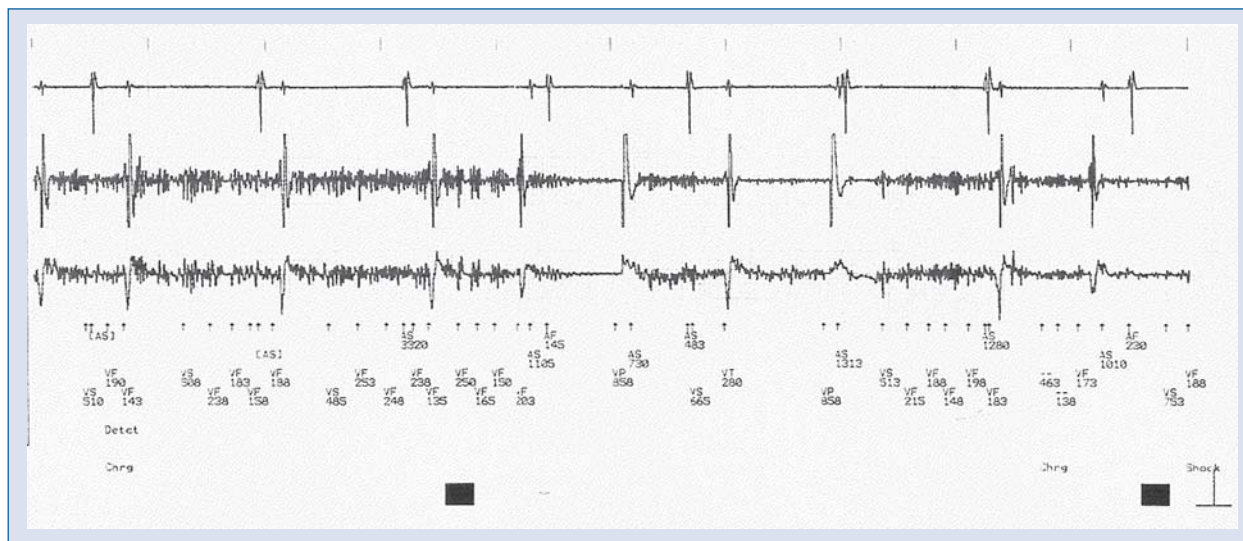
Figure 1. Interrogation of the defibrillator shows stored intracardiac electrograms (EGMs) of the event. The EGMs are recorded from the right atrial (RA) channel (top), the right ventricular (RV) pace/sense channel (middle), and the high voltage (HV) shock coil channel (bottom). The device misinterprets high frequency low voltage noise as ventricular sensed (VS), ventricular tachycardia (VT) and ventricular fibrillation (VF) events. When the therapy criteria for VF are met, the device charges (Chrg) and delivers shock (shock).

He returned to the hospital six weeks later complaining of recurrent shocks from the ICD. Each shock occurred with left arm movement, predominantly when scratching the right side of the abdomen with his left hand. Interrogation of the device demonstrated many diverted charges, as well as 11 delivered shocks (Fig. 1). The pacing and sensing thresholds data and the pacing and shock coils impedances were all unchanged from the implant data. The findings on the intracardiac electrograms (EGMs) recorded during the shocks were reproduced with the left arm movement at the bedside. Chest X-ray did not demonstrate any apparent conductor or lead fracture.

Pertinent to our case, normal RV lead parameters made the possibility of lead fracture unlikely. The presence of high frequency, low-amplitude noise with arm movement raised the suspicion of myopotential oversensing. Diaphragmatic myopotential oversensing is more common during periods of straining or valsalva maneuvers, while arm movement makes pectoral myopotential oversensing more likely.

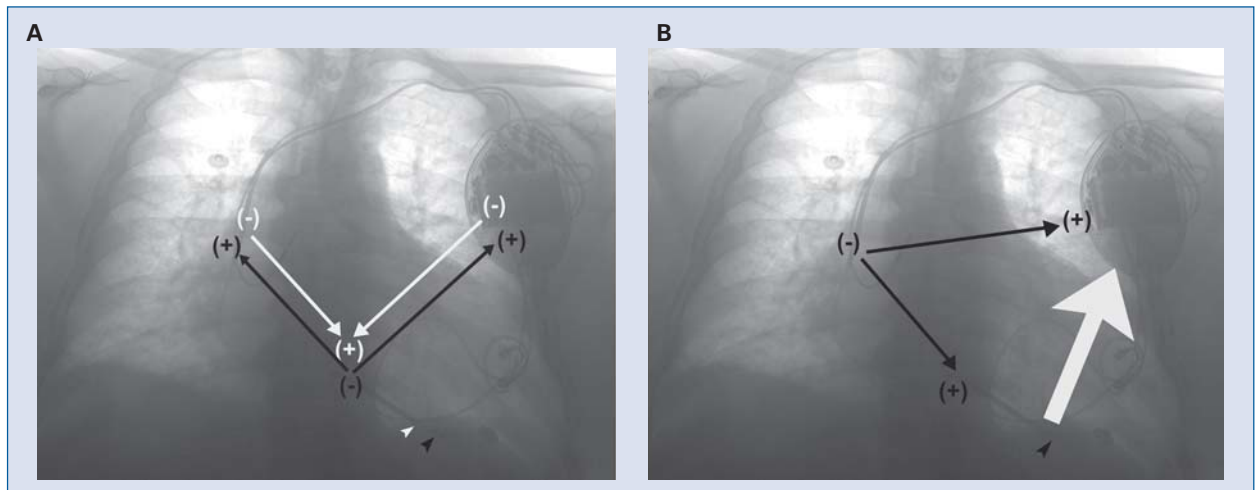
The patient returned to the electrophysiology laboratory for further examination and potential revision of the system. The RV lead appeared intact. However, the proximal (+) superior vena cava and the distal (-) RV high voltage lead terminals were found to be reversed in the header of the ICD.

Figure 2. The chest X-ray shows cardiac resynchronization therapy-defibrillator device (CRT-D) system with the right ventricular (RV), left ventricular epicardial and the right atrial leads. As shown in (A), normal bipolar sensing vector is from the tip of the RV lead to the distal RV coil (black and white arrowheads respectively). With conventional connection, the defibrillator shock energy flows from the RV distal coil (-) to the superior vena cava (SVC) coil (+) and the generator (+) (black arrows). When the reversed lead polarity is 'programmed', the defibrillator shock energy flows from the SVC coil (-) and the generator (-) to the RV distal coil (+) (white arrows). In both cases, the shock energy is focused in the ventricle. As shown in (B), when the distal (-) and proximal (+) pins are physically reversed in the implantable cardioverter defibrillator header ports, a broad unipolar sensing configuration occurs between the lead tip and the generator (black arrowhead and a broad white arrow respectively), and the defibrillator shock energy flows from the SVC coil (-) to the generator (-) and to the RV distal coil (+) (black arrows).

In our patient's ICD system, the RV lead was an integrated bipolar lead. In this lead, bipolar sensing is accomplished from the tip of the RV lead to the distal RV coil (black and white arrowheads respectively, Fig. 2A). The proximal (+) port in the header is hardwired to the generator. Therefore, when the distal (-) and proximal (+) pins are physically reversed in the ICD header ports, a broad unipolar sensing configuration occurs between the lead tip and the generator itself (black arrowhead and a broad white arrow respectively, Fig. 2B).

In addition, unlike reversing the shocking polarity with electronic programming (Fig. 2A), with physical reversal of the pins in the header, a shocking configuration occurs which diverts energy away from the ventricles, potentially leading to high DFTs or inability to defibrillate (Fig. 2B). This latter

It is also worth noting that the words 'proximal' and 'distal' on this four year old lead were difficult to read. Due to the battery drain from the multiple shocks and diverted charges, a new CRT-D device was implanted as recommended by the manufacturer. The patient did well post-operatively and had no further inappropriate shocks or device malfunction during a follow-up period of six months.
