Late complication of heart stimulation — lead abrasion in pacemaker pocket

Odległe powikłanie stymulacji serca — przetarcie elektrod w loży urządzenia

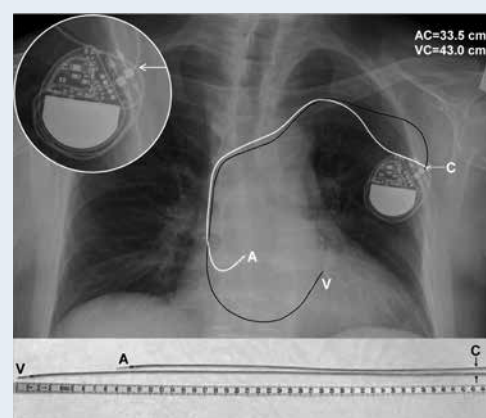
Figure 4. Chest X-ray — postero-anterior projection; A — atrial lead; V — ventricular lead; C — the site of mutual contact of leads in the pocket. In the circle can be seen magnification of the site C
