Fracture of the distal part of an implantable cardioverter-defibrillator lead two months after implantation

Muhammet Dural, Kadir Ugur Mert, Selda Eraslan, Kemal Iskenderov, Yuksel Cavusoglu

Cardiology Department, Eskisehir Osmangazi University, Büyükdere Mahallesi, Eskisehir, Turkey

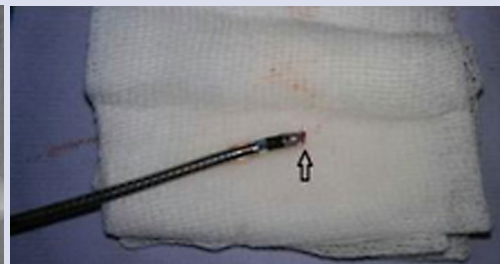
Figure 3. Macroscopic view of the fractured lead

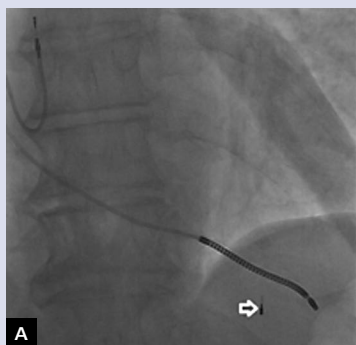
A

Figure 2. A. Complete ventricular lead fracture at the distal part of the electrode; B. Embolised distal part of the lead to the right pulmonary artery

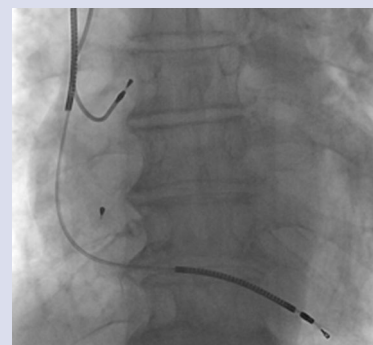
Figure 4. Implanted new ventricular lead
