## Misguided pacemaker lead

Thang Nguyen<sup>1</sup>, Matthew Lytwyn<sup>2</sup>, Brett Memauri<sup>3</sup>, Davinder S. Jassal<sup>1, 2, 3</sup>, Aliasghar Khadem<sup>1</sup>

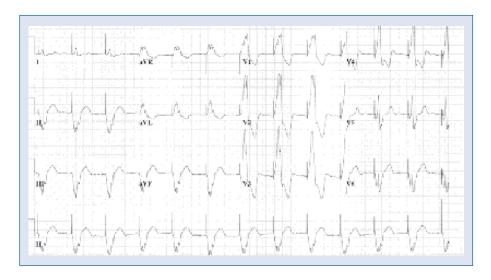
As part of the pre-operative evaluation, the patient had an electrocardiogram (ECG) which revealed ventricular paced rhythm with right bundle

Figure 1. Electrocardiogram which revealed ventricular paced rhythm with right bundle branch block morphology.

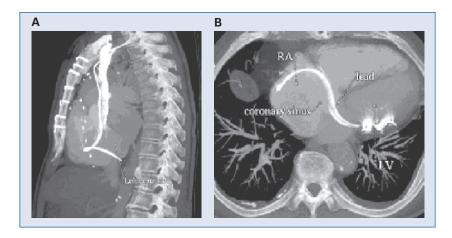
branch block (RBBB) morphology (Fig. 1). Computed tomography of the chest demonstrated a single ventricular lead, posteriorly directed towards the left ventricle (LV) (Fig. 2A). The tip of the lead traveled from the right atrium through the coronary sinus and resided within the infero-posterior coronary vein over the LV (Fig. 2B). Transthoracic echocardiography revealed no evidence of a pericardial effusion, atrial septal defect, nor ventricular septal defect. Upon review of past ECGs, it was confirmed that the RBBB morphology pattern had been present since the time of insertion. The patient con-

**Figure 2. A.** Computed tomography of the chest demonstrated a single ventricular lead, posteriorly directed towards the left ventricle; **B.** The tip of the lead traveled from the right atrium (RA) through the coronary sinus and resided within the infero-posterior coronary vein over the left ventricle (LV).

the CS during single lead pacing is rare, but should be entertained in the differential diagnosis with RBBB on ECG post-implantation.
