Spontaneous pacemaker distal lead tip migration resulting in lack of ventricular stimulation

(Folia Cardiologica 2014; 9, 2: 179–181)

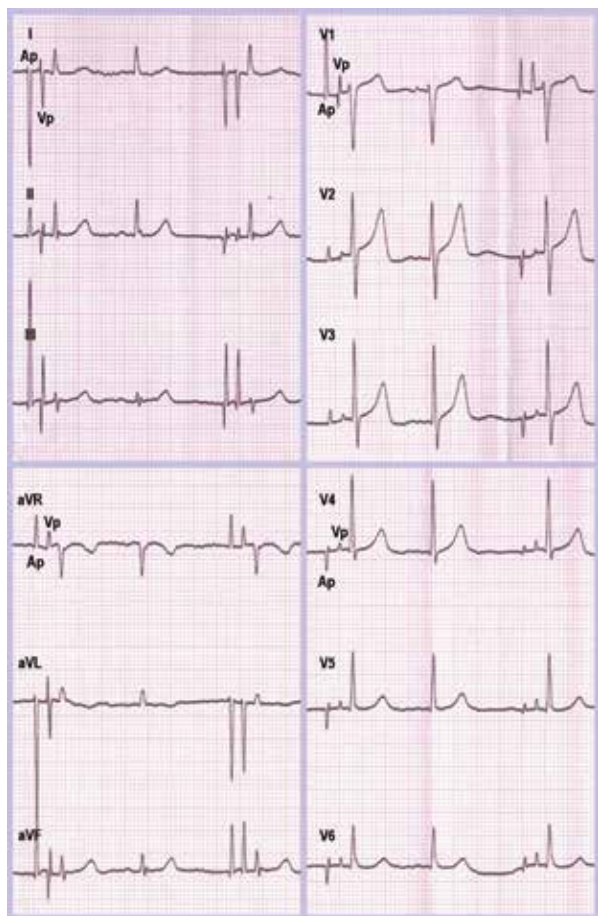
88-year-old male with a history of ischemic cerebral infarction, arterial hypertension and type 2 diabetes mellitus was admitted to hospital after transient ischemic attack for further neurological diagnostics. ECG at admission showed ineffective ventricular stimulation (Fig. 1).

Figure 1. ECG at admission – ineffective ventricular stimulation

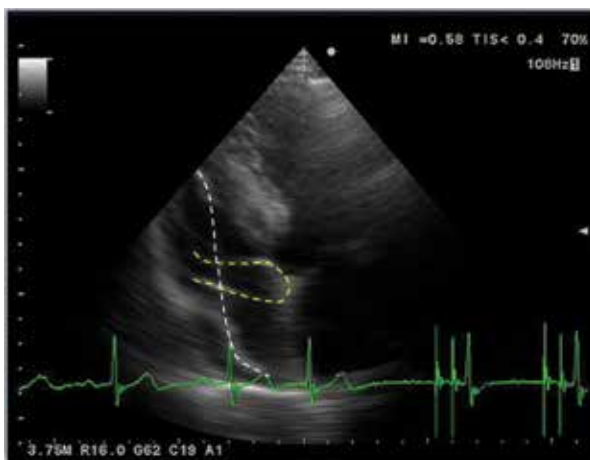
A DDDR pacemaker with active fixation leads was implanted 14 months previously for sick sinus syndrome. The procedure was complicated by pneumothorax. After the implantation patient did not present for a follow-up visit. Telemetric pacemaker control confirmed lack of ventricular stimulation. It also showed that both ventricular and atrial channel stimulation resulted in atrial stimulation with excellent electrical parameters but with different P wave morphology (Fig. 2). Excessive lead bending at tricuspid valve level was present in transthoracic echocardiography

Figure 3. Transthoracic echocardiography – excessive lead bending at tricuspid valve level

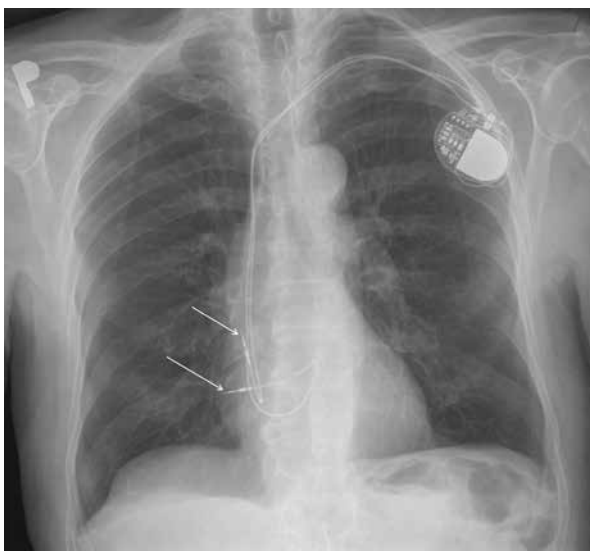
(Fig. 3). Chest X-ray confirmed that both lead tips were positioned in right atrium (Fig. 4). Patient was scheduled for transvenous ventricular lead extraction.

Figure 4. Chest X-ray – both lead tips visible in right atrium

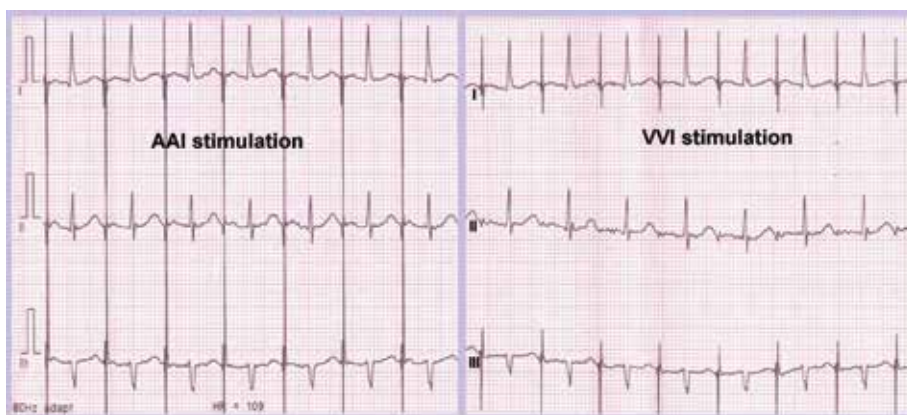
Figure 2. Atrial stimulation in both ventricular and atrial channels with different P wave morphology
