The random placement of pacing lead in the left ventricle in a patient with patent foramen ovale

Folia Cardiologica 2016; 11, 6: 535–538

Case report

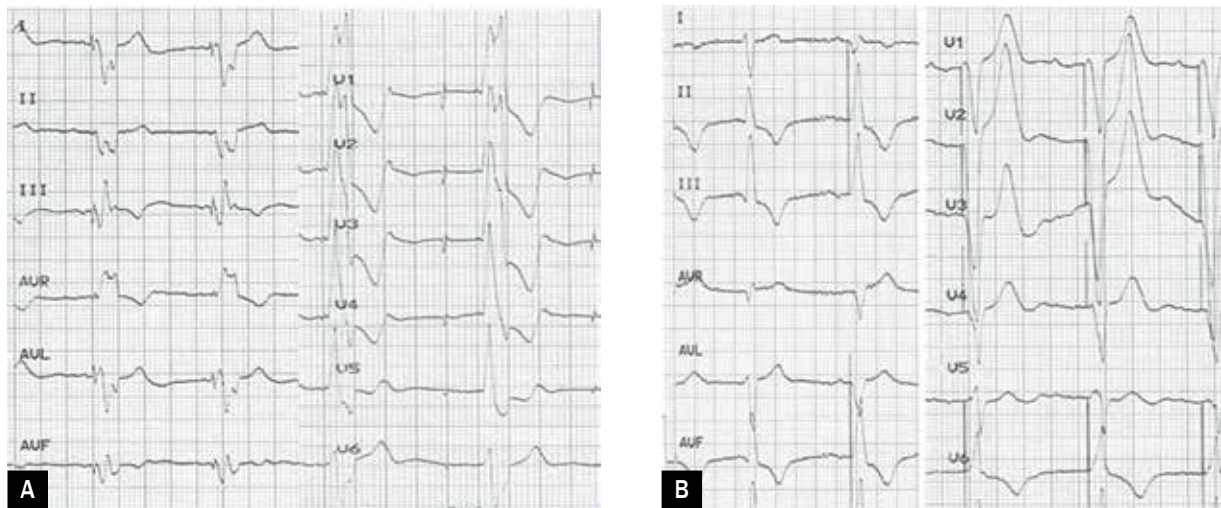
Figure 1A, B. Electrocardiography: right bundle branch block (RBBB) pattern (A); left bundle branch block (LBBB) pattern (B)

The basic diagnostic tool to rank the correct position of the pacing electrode is a 12-lead ECG. Proper stimulation of the right ventricle gives a complete left bundle branch block (LBBB), usually with a sinistrogram. In contrast, stimulation of the left ventricle results in the right bundle branch block (RBBB), usually with the dextrogram. However, presence of RBBB in ECG during ventricular pacing not always proves wrong position of the electrode [4]. Right bundle branch block may occur in the case of placing the electrode in the coronary sinus or in the left ventricle of the heart or may occur as a result of septal or right ventricular free wall perforation. There are a few cases of atypical right bundle branch block (so-called the pseudo RBBB – in ECG in lead I, aVL is typical LBBB, and in V1–V3 is typical RBBB) in case of normal right ventricular apical pacing or apical segment of the septum in right ventricle, which can cause early left ventricular pacing. Moreover, if the ECG recording is technically wrong it can be mistakenly interpreted as a RBBB; the displacement of electrodes V1–V3 by one intercostal space below can normalize the ECG [4, 5]. The shape of the QRS with morphology RBBB during right ventricular pacing can be distinguished from the shape of the QRS with morphology RBBB during left ventricular pacing according to the criteria described by Okmen et al.: left axis deviation to the left in the frontal plane between -30 and -90 degrees, the transition zone in V3 lead (R-wave amplitude equal to the S-wave amplitude), the lack of S-wave in lead I and the sets of qR or RS in V1 lead. Nevertheless, each case of RBBB in ECG requires an accurate assessment of the electrode location [6].

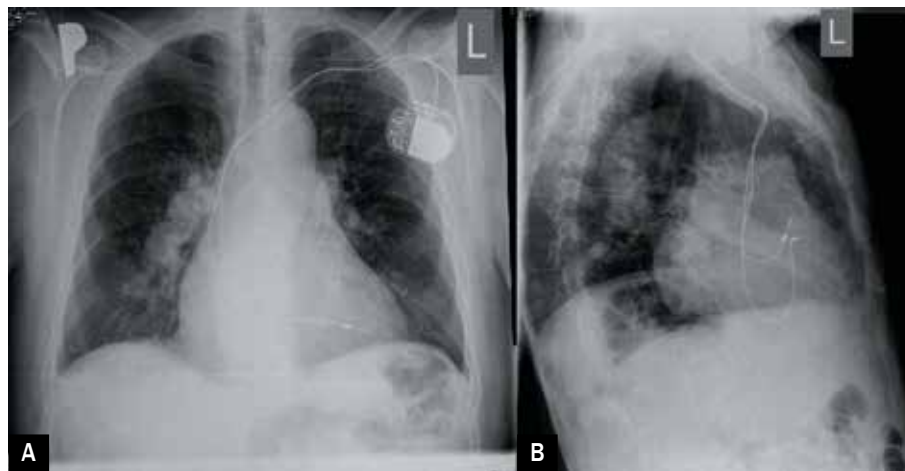
Figure 2A, B. Chest X-ray in posterior-anterior (PA) and lateral projections

The next step is to perform chest X-ray in the PA and lateral projections. Routine chest X-ray projection (PA) very often does not reveal any abnormalities. The lateral projection can be also correct in many cases. The most accurate study to evaluate the pacing lead fixation and to trace its exact course in the heart is transthoracic echocardiography, and especially transesophageal echocardiography [5, 7, 8]. In each case of suspicions of incorrectly located pacing leads the echocardiography should be performed.

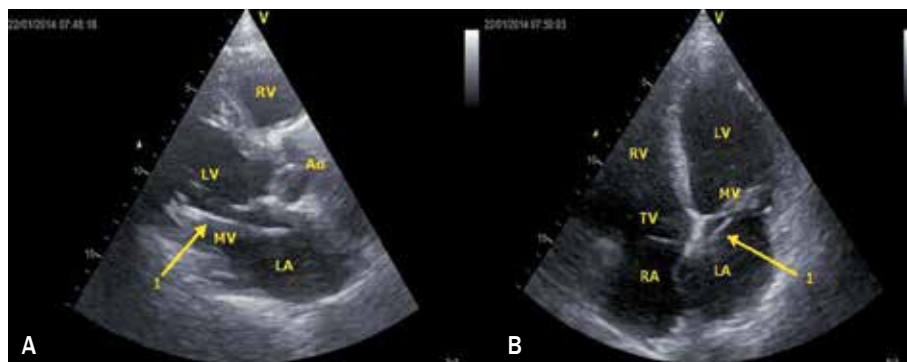
A 74-year-old male was admitted to the Department of Cardiology, due to atrioventricular arrhythmia (second degree atrioventricular block 2: 1) with MAS syndrome. During hospital admission the patient was secured by a temporary transvenous pacing electrode. The next day the DDDR pacemaker was implanted. After surgery, on ECG recording right bundle branch block (RBBB) configuration of paced complexes were present (Figure 1A). The chest X-ray in posterior-anterior (PA) and lateral projections were correct (Figure 2). The transthoracic echocardiography showed wrong location of pacing lead in the left ventricle (pacing electrode passed from the right atrium by the foramen ovale into the left atrium and then through the mitral valve into the left ventricle of the side wall) (Figure 3). To confirm a malposition of the electrode and to exclude

Figure 3A, B. The transthoracic echocardiography. The arrow indicates pacing electrode [1]; LA – left atrium; RA – right atrium; LV – left ventricle; RV – right ventricle; Ao – aorta; TV – tricuspid valve; MV – mitral valve

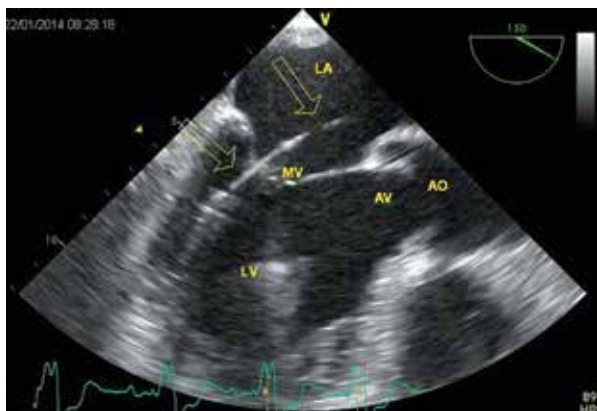
possible artifacts, the transesophageal echocardiography was done. It also showed an incorrect position of ventricular electrode (Figure 4), current patent foramen ovale (PFO) and a trace of the left-to-right leak through the interatrial septum around the passage of the lead (Figure 5). The next day of hospitalization repositioning ventricular electrode was done. After the procedure, the control ECG showed normal right ventricular stimulation with left bundle branch block (LBBB) (Figure 1B). The echocardiography showed the correct location of the pacemaker electrodes, there was no damage to the structures of the heart or leakage through the septum. Control stimulation parameters were correct.

Figure 4. Transesophageal echocardiography. Pacing lead passing from the right to the left atrium (LA) and through the mitral valve (MV) into the left ventricle (LV); Ao – aorta; AV – aortic valve

If the malposition of pacing lead is detected early after surgery it is possible to remove the electrodes usually by transvenous access. Transvenous lead extractions are effectively accomplished in many hospital centers by qualified doctors and with various techniques. Surgical lead extraction should be taken into consideration, especially if the cardiac surgery has to be performed because of other indications or in case of serious complications such as pericardial perforation [5, 7, 8]. If the leaving of pacing electrode in the left ventricle is necessary, anticoagulants (acenocoumarol or warfarin) must be given with therapeutic range of international normalization ratio (INR) between

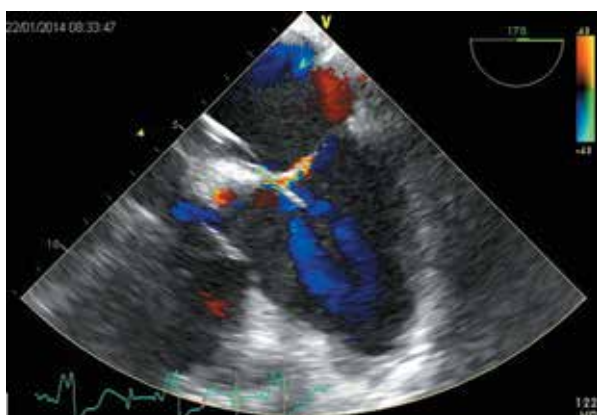
Figure 5. Transesophageal echocardiography. Visible trace of the interatrial septum leak
