# Intracardiac damage of silicone insulation of a single lead and infective endocarditis

Barbara Małecka<sup>1</sup>, Anna Rydlewska<sup>1</sup>, Andrzej Ząbek<sup>1</sup>, Jerzy Sadowski<sup>2</sup>, Jacek Lelakowski<sup>1</sup>

<sup>1</sup>Department of Electrophysiology, John Paul II Hospital in Krakow, Poland

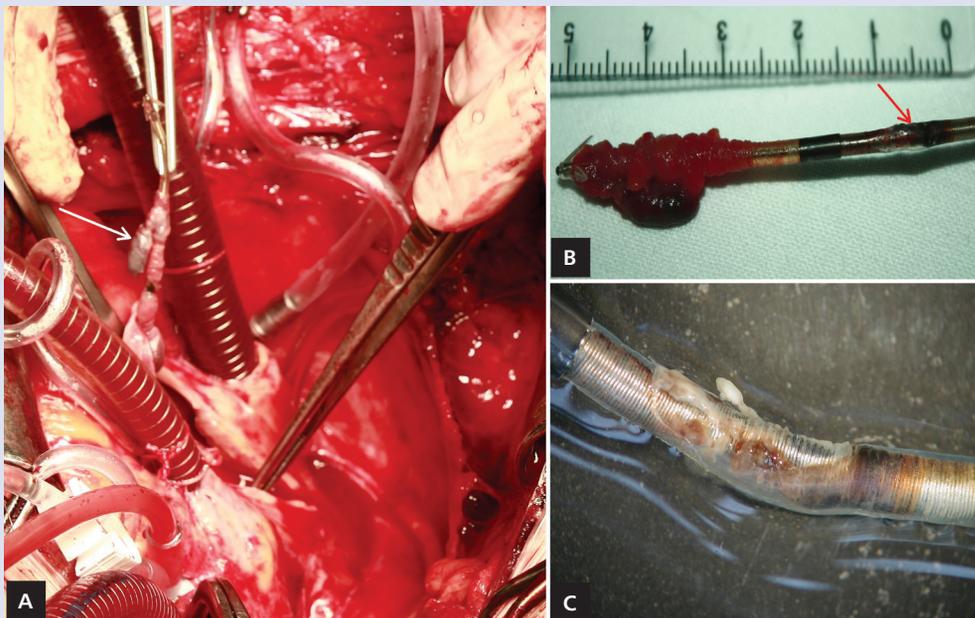
A 59-year-old woman after artificial mitral valve and pacemaker implantation (VVI with ventricular lead Biotronik Synox 60BP) underwent cardiac surgery due to infective endocarditis. Transoesophageal echocardiography performed to diagnose recurrent septic fevers revealed vegetations connected to the pacemaker lead and artificial valve, and computed tomography confirmed multiple pulmonary embolisms. No pacing or sensing abnormalities of the pacemaker were present. Endocardial pacing lead, together with artificial valve, was removed using extracorporeal circulation. Simultaneously, a new mitral valve and an epicardial pacing system were implanted. The lead unseal with metal wire exposure was discovered (Fig. 1B). In this location, vegetation infected with *Staphylococcus* was attached to the lead (Fig. 1A). The 9-year-old lead was damaged at its passing through the tricuspid valve. The use of an optical microscope confirmed silicone layer reduction up to a complete absence of the outer lead insulation (Fig. 1C). In spite of antibiotic and cardiosurgical therapy, the patient died due to septic shock. Lead-dependent infective endocarditis (LDIE) associated with abrasion of silicone insulation of two endocardial leads as a result of their friction in the right atrium has been previously described. We have also described abrasion of silicone insulation in intracardiac parts of pacemaker leads as a new mechanism of LDIE. In this case, abrasion with disruption of silicone insulation occurred in a single lead system implanted 9 years previously. A possible cause of damage was lead abrasion due to its contact with the tricuspid valve and silicone wear caused by lead bending. LDIE followed by pulmonary embolism and artificial mitral valve infection was associated with mechanical damage of the lead and resulted in the patient's death. Damage of lead insulation was electrically silent. Damage of the endocardial pacemaker lead with disruption of outer silicone insulation and metal wire exposure may occur in the presence of a single lead. LDIE with severe clinical presentation and lack of heart stimulation malfunction may be a symptom of such damage.

**Figure 1.** A. Operating table: surgically removed lead with attached infected vegetation (arrow); B. Site of isolation disruption with exposure of the lead inside filled with haemolysed blood (arrow); C. Macrophotography — silicone insulation reduction, up to complete lack of isolation and metal wire exposure
