# Spontaneous dislocation of the endocardial lead into the left ventricle through the intraventricular septum

Krzysztof Boczar<sup>1</sup>, Monika Komar<sup>2,3</sup>, Andrzej Ząbek<sup>1</sup>, Jacek Lelakowski<sup>1,3</sup>, Barbara Małecka<sup>1,3</sup>

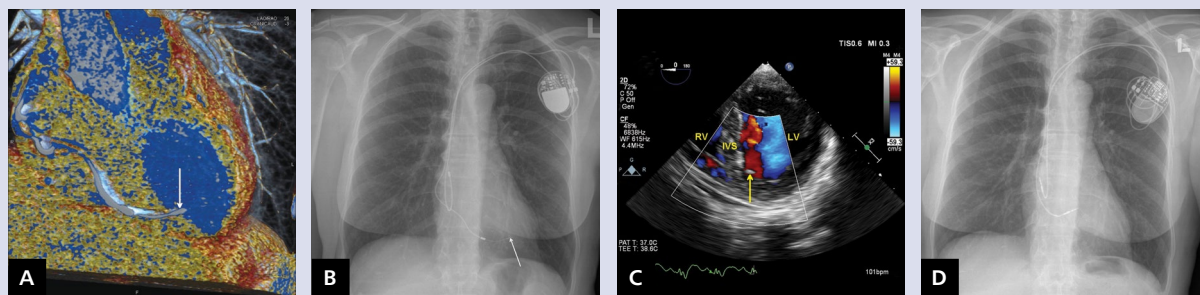
We report a case of a 66-year-old woman with a history of DDD pacemaker implantation in 2005 due to vasovagal syncope and generator change in 2014. The patient was implanted with an atrial lead Biotronik SX 53-JBP positioned in the right atrial appendage and a ventricular lead Biotronik SX 60-BP positioned in the right ventricular apex. A few months after generator change the patient underwent a diagnostic process due to heart palpitations and stabbing pain in the chest. The chest pain occurred during body movements and deep breathing. In electrocardiographic Holter monitoring the sensing disturbances in the ventricular channel were detected. During pacemaker interrogation the electrical parameters of both leads were normal except for an increased number of short V-V intervals. The patient was qualified to transvenous ventricular lead extraction and implantation of a new ventricular lead. In the meantime the patient underwent a computed tomography scan in search of coronary heart disease, and it was found that the ventricular lead was perforating the intraventricular septum on the level of the apical septal segment. The length of the lead in the left ventricle amounted to 7–9 mm (Fig. 1A). The displacement of the lead was suspected also in a chest X-ray of the current location of the lead (Fig. 1B). In transthoracic and transoesophageal echocardiography the thrombus on the lead tip and left-to-right shunt through the septum along the lead were ruled out (Fig. 1C). The decision to extract the ventricular lead transvenously with mechanical systems with surgical backup and transoesophageal echocardiography monitoring was upheld. The procedure was a complete success. There was no residual left-to-right shunt after the extraction of the lead. Subsequently the new ventricular lead was implanted (Fig. 1D). The presented case is an example of a rare and dangerous complication of permanent pacing. The existence of a short portion of ventricular lead inside the left ventricle posed a risk of thrombus formation and peripheral embolisation, of which the most dangerous is stroke. The late perforation of intraventricular septum by a passive fixation lead has not been reported in English-language literature yet. The probable cause of the distant (in time) perforation was the application of excessive force on the tip of the lead during implantation, which was then aggravated by the ingrown lead into the tricuspid valve region. Transvenous extraction of the lead displaced into the left ventricle requires surgical intervention according to the current Heart Rhythm Society (HRS) expert consensus. In this case a less invasive approach was successfully used. However, close attention was directed toward identification and prevention of potential perioperative complications such as left-to-right shunt after lead extraction and arterial embolisation. Furthermore, the procedure was conducted with surgical backup and continuous intraoperative transoesophageal monitoring.

**Figure 1.** **A.** Computed tomography scan, arrow indicates the tip of ventricular lead in the left ventricle; **B.** Chest X-ray before transvenous lead extraction procedure, arrow indicates displaced tip of the ventricular lead; **C.** Transoesophageal echocardiography with colour Doppler, arrow indicates right ventricular lead in left ventricle (LV); RV — right ventricle; IVS — intraventricular septum; **D.** Chest X-ray after implantation of new DDD pacemaker
