Early abdominal aortic rupture after Nellix endovascular aneurysm sealing

Abstract

Acta Angiol 2018; 24, 2: 51–53

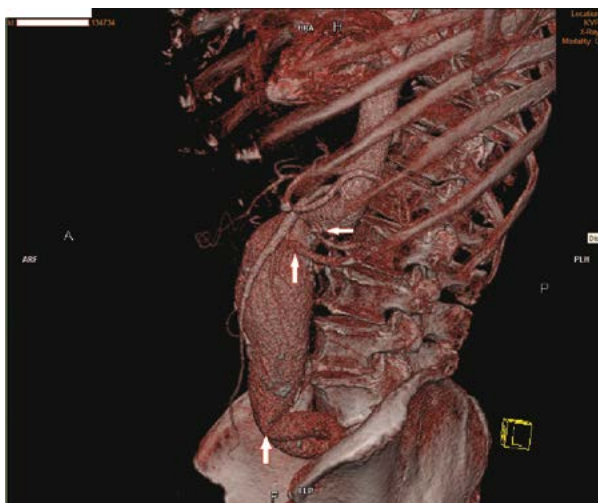
Figure 1. Left renal arteries, left iliac artery

The anatomy of the aneurysm was complex. Each of the kidneys was supplied by two renal arteries. In both cases the lower renal arteries were dominant. The left lower renal artery originated from the aneurysm (Fig. 1). The right lower renal artery originated just a few millimeters above the aneurysm (Fig. 2), the aortic diameter at that level was 26 mm. In addition, the aorta above was “Z” shape angulated (Fig. 1). Both iliac arteries were patent. The left iliac artery was over 90° angulated (Fig. 1).

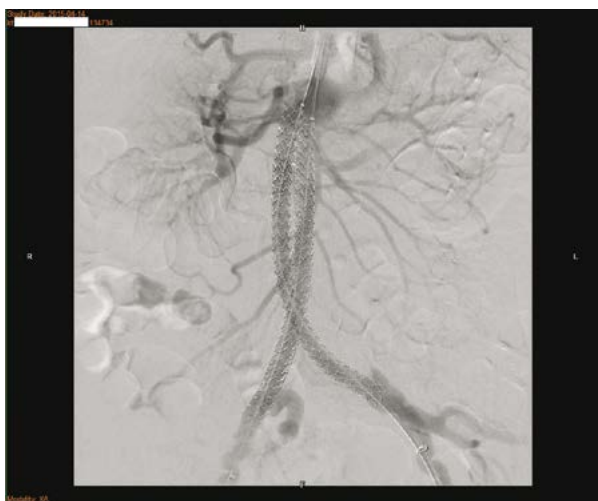
Figure 3. Completion angiography

The procedure was successful and the completion angiography showed EVAS with no endoleak (Fig. 3). The right lower renal artery was not sealed and the right kidney circulation was normal. The left lower renal artery was closed, as intended. Circulation in the left kidney was impaired.

Nellix EVAS is not a 100% successful AAA repair method. The EVAS FORWARD study revealed freedom from reintervention on the 12th month was 98% when used inside the IFU (instructions for use), compared to 86% if outside the IFU (as in this case). The presented case brings more questions than answers. No endoleak was identified in completion angiography. This suggests that the implant migrated soon after the

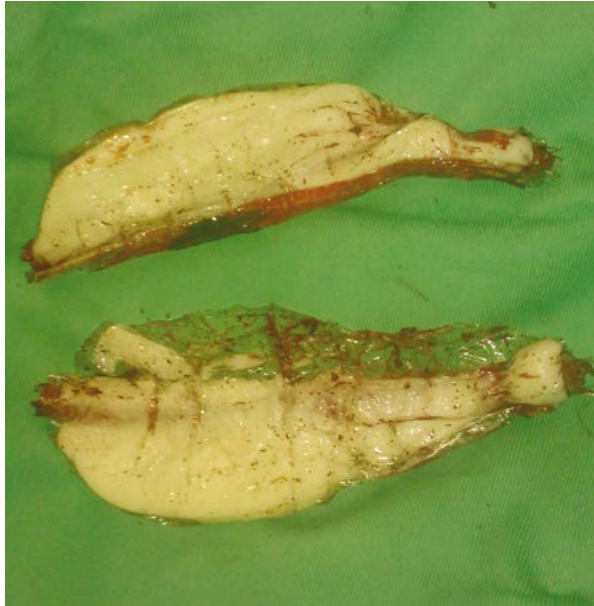
Figure 5. Nellix stents after explantation

In the examination of the removed Nellix none of the elements appeared to be damaged. Endobags were not torn, the polymer was firm (Fig. 5).
