Successful endovascular management of inadvertent catheterization of subclavian artery

Acta Angiol 2024; 30, 1: 25–28

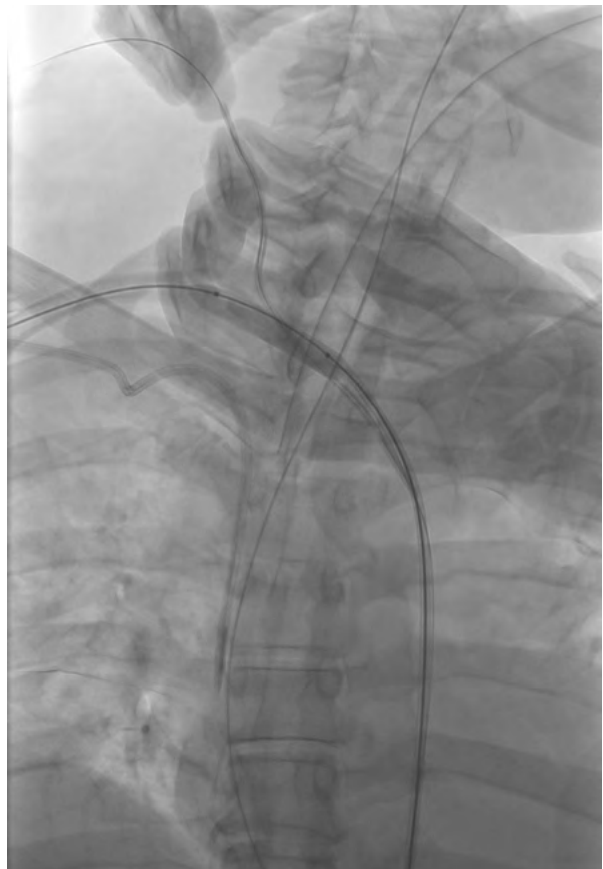
Figure 2. Intraoperative arteriography showing the moment of introducing an arterial closure device insertion sheath over the guidewire

introduced through the CVC catheter into a descending aorta. The RSA balloon was inflated again, the CVC catheter was removed, and an arterial closure device insertion sheath was introduced over the guidewire while the RSA balloon was being deflated (Fig. 2). RSA puncture was closed with an arterial closure device in a standard fashion.

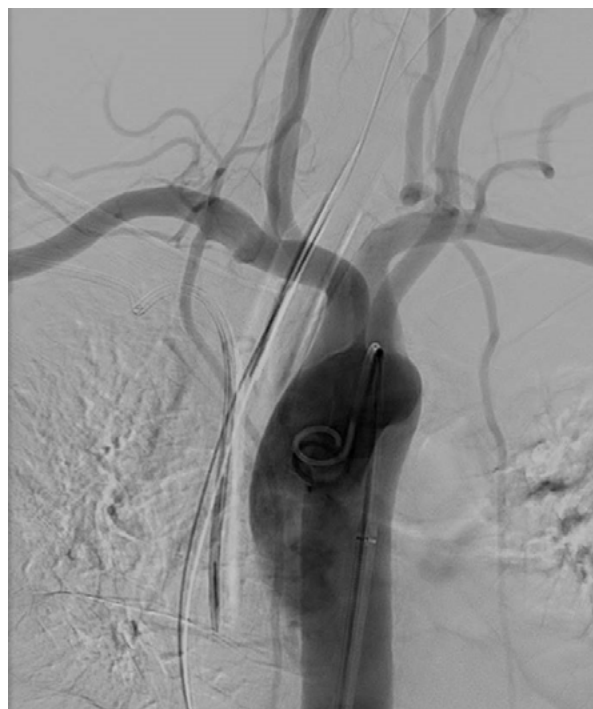
Figure 3. Intraoperative arteriography showing the patency of the subclavian artery and a complete seal of the puncture site

The completion arteriography demonstrated the patency of the subclavian artery and a complete seal of the puncture site (Fig. 3). The balloon catheter was removed.
