Mitral valve prosthesis abruption

Cardiology Department of T. Marciniak Hospital, Wrocław, Poland

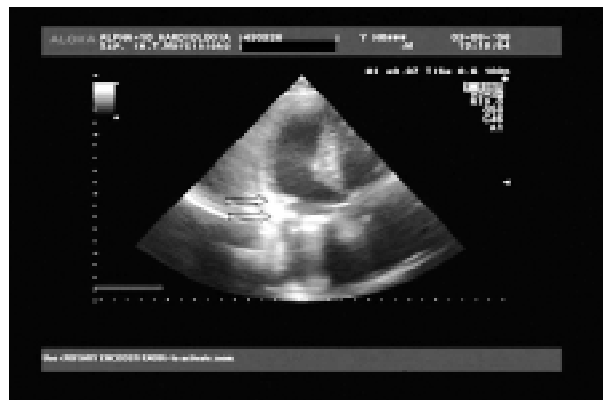
Figure 2. Apical 3-chamber view (A3C) showing the prosthesis echogram 10–15 mm (arrow) above the level of the native mitral annulus (arrow).

The transthoracic echocardiogram demonstrated an abnormal position of the mitral valve prosthesis. It was relocated towards the left atrium. In the apical views, the prosthesis echogram was registered about 10–15 mm above the level of the native mitral annulus (Figs. 1, 2). Mobility of the mitral prosthesis was abnormally large in the vertical direction. Around the posterior pole of the prosthesis annulus, a lack of contact between the prosthesis and cardiac wall was observed (Fig. 3). In this place, a perivalvular shunt could be detectable (Fig. 4). In colour Doppler mapping, a left atrio-ventricular flow seemed, in some places, a bit “deluging” (Fig. 4).

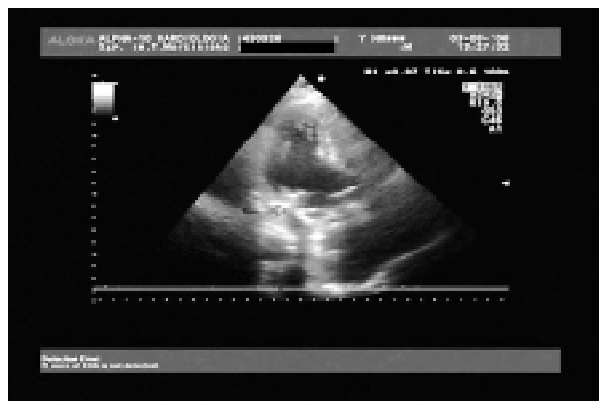
Figure 3. Apical 3-chamber view showing lack of contact between the prosthesis and cardiac wall (arrow).

Because of the suspicion of prosthesis abruption, the patient was qualified for an urgent reoperation. An uncomplicated replacement of the mitral valve prosthesis was performed. The mitral valve

prosthesis abruption along a large segment of its circumference was affirmed. Evidence of prosthesis infection was not present.

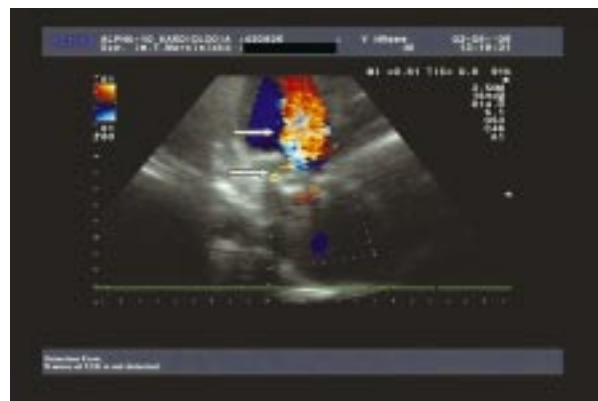
This feature also suggested a perivalvular shunt. The pressure gradient of the mitral prosthesis was slightly increased (22 mm Hg). Evident features of infective endocarditis were not noted in the transthoracic echocardiogram.

Figure 4. Colour-Doppler in A3C showing the perivalvular shunt (behind the posterior pole of the prosthesis) and "deluging" transmitral flow (arrows).
