Folia Cardiologica 2023 vol. 18, no. 4, pages 173-175 DOI: 10.5603/FC.a2023.0016 Copyright © 2023 Via Medica ISSN 2353-7752 e-ISSN 2353-7760

Acute tricuspid valve regurgitation in a motorcycle accident

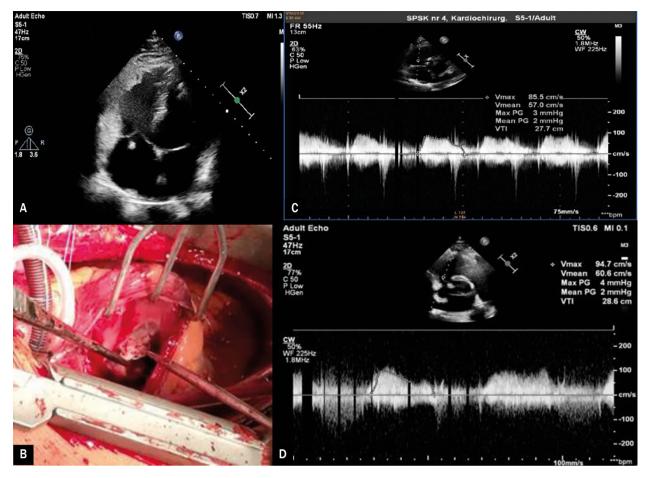
Figure 1. A. Fragment of the papillary muscle in the right atrium — echocardiography image; **B.** Fragment of the papillary muscle — intraoperative image; **C.** Discharge echocardiography of the first patient; **D.** Discharge echocardiography of the second patient

An 18-year-old man suffered severe tricuspid regurgitation and orthopaedic injuries in a motorcycle accident. In 3 months, the patient underwent orthopaedic treatment and cardiological control to qualify for cardiac surgery. Echocardiography showed severe tricuspid regurgitation, caused by a rupture of the papillary muscle leading the tendon threads to the anterior leaflet of the tricuspid valve. The left ventricular ejection fraction was 55%, and the patient complained of exertional dyspnoea, which corresponded to New York Heart Association class II. The patient was qualified for cardiac surgery to correct the valve defect. A sternotomy and cannulation of the ascending aorta and both vena cava were performed. On the beating heart, after opening the right atrium, the tendon threads of the anterior leaflet were sutured to the muscle of the right ventricle. Edwards MC3 34 ring was sewn in for stabilization. Follow-up transoesophageal echocardiography showed insignificant, small tricuspid regurgitation. Echocardiographic control after 4 months showed no significant changes.

A 26-year-old man suffered a traffic accident as a motorcycle driver. The patient underwent type II ASD correction surgery in childhood. After the accident, the patient was hospitalized for 5 days at the Department of General Surgery due to concussion, right shoulder injuries and right lung contusion. Three days after discharge from the hospital, he went to the ER for stabbing chest pain. Echocardiography revealed significant tricuspid regurgitation and a ballot formation on the tricuspid valve. A cardiac angio-CT examination confirmed a rupture of the papillary muscle of the right ventricle. The patient was admitted to the Department of Cardiac Surgery in a semi-elective mode for surgical correction of valve defect. A surgical procedure was performed in extracorporeal circulation, including resternotomy, suturing of the torn papillary muscle of the

anterior leaflet to the right ventricular wall, and insertion of the Edwards MC3 Tricuspid Annuloplasty Ring 32. Intraoperative transoesophageal echocardiography confirmed the proper functioning of the valve after surgery. The course of hospitalization was uncomplicated.
