The morphological conditions of the permanent pacemaker lead extraction

Pacemaker lead extraction is the treatment of choice in infectious complications regarding implantation procedure. The purpose of this study was to estimate the safety of the extraction in relation to the morphological changes of the pacing electrode. Research was carried out on materials consisting of 60 human hearts from 45 to 95 years of age (average 63 ± 15 yrs), with VVI or DDD pacing (pacing duration 84 ± 26 months) fixed in a formalin solution. Classical macroscopic anatomical methods were applied.

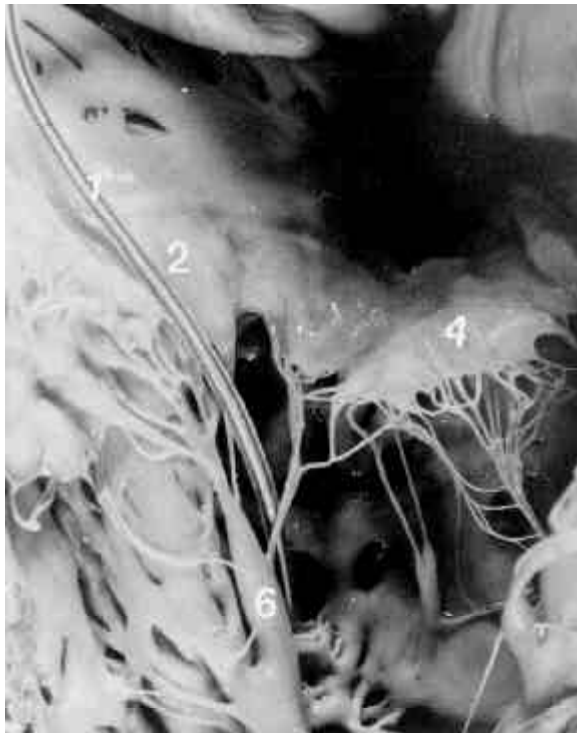
Figure 2. Polyurethane-insulated electrode without any fibrous tissue positioned between chordae tendinae. Denotations see Fig. 1 (♂42 year-old, 2 months after implantation)

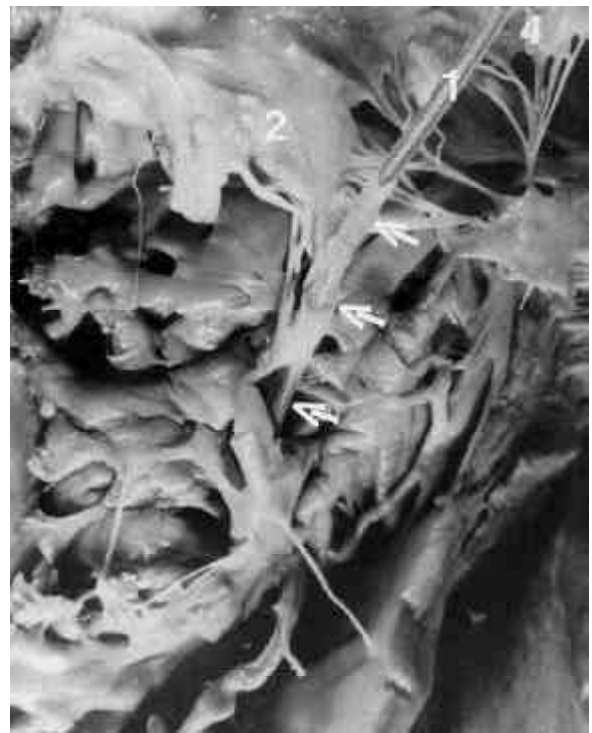
Figure 3. Silicone-insulated electrode entrapment (adhered) to the tricuspid valve ensheathed with fibrin (arrows). Denotations see Fig. 1 (♀70-year-old, 16 months after implantation)
