# Embolisation of permanent pacemaker lead to pulmonary artery: a 15-year follow up

Hakan Erkan<sup>1</sup>, Oğuz Varol<sup>1</sup>, Ayşegül Karadeniz<sup>1</sup>, Merve Erkan<sup>2</sup>

<sup>1</sup>Ahi Evren Cardiovascular and Thoracic Surgery Hospital, Turkey

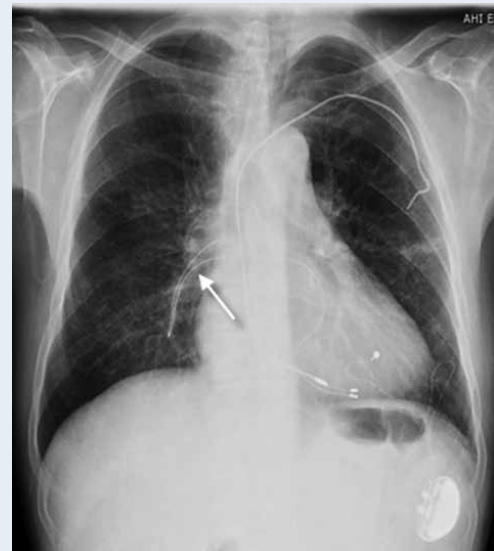
**Figure 1.** On chest X-ray, right side pacemaker lead proximal tip (arrow) was migrated from right subclavian vein to pulmonary artery

A 78-year-old man was admitted to the hospital for epicardial pacemaker (PM) battery replacement. His past medical history included PM pocket infections on both infraclavicular sides. Simple traction to remove the non-functioning leads was ineffective. Therefore bilateral endocardial leads were left in place with removal of infected batteries. Meanwhile, he underwent epicardial permanent PM implantation. At the six month control, echocardiography and computed tomography (CT) showed that the right abandoned subclavian lead had migrated to the pulmonary artery. He has been followed with this migrated lead to the pulmonary artery since 1998. In the present report, we would like to show the extraordinary position of the right subclavian lead with multiple imaging modalities. Chest X-ray is compatible with migrated proximal end, with distal tip remaining fixed at right ventricular apex (Fig. 1). Echocardiographic evaluation demonstrated that the PM lead had crossed the pulmonary valve and was stuck in the pulmonary artery (Fig. 2). Finally, CT imaging clearly showed that the proximal tip of the PM lead was embolised to the right pulmonary artery (Fig. 3). His medical treatment had included only oral anticoagulation because of atrial fibrillation of several years' duration. It is worth noting that during the 15-year follow up, there has been no complication related to the lead embolism. Therefore, we decided to follow up the patient without intervention.

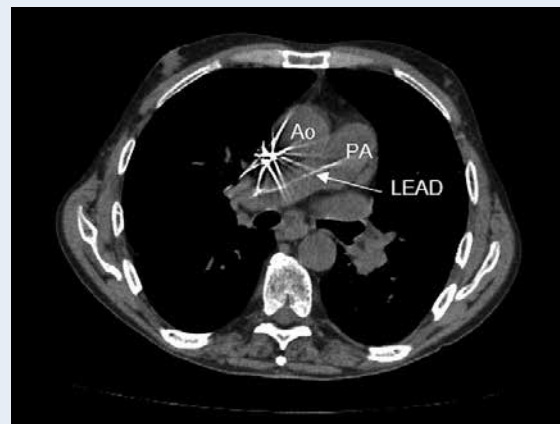
**Figure 3.** Computed tomography imaging showed that the proximal tip of pacemaker lead was embolised to the right pulmonary artery (PA); Ao — aorta
