# In-stent balloon rupture and entrapment during post-dilatation in an infarct-related artery followed by successful retrieval

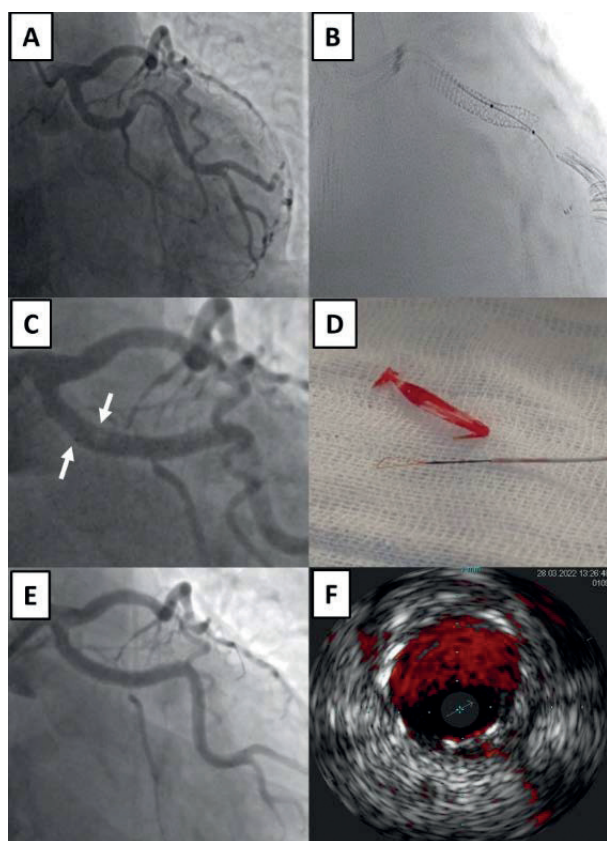
**Figure 1.** **A.** Initial left coronary artery angiography with the thrombus in mid-Cx (the arrow). **B.** Post-dilatation of the stent with a 4.5 × 20 mm non-compliant balloon inflated to 24 atm. **C.** Control angiography showing distal marker and fragment of the defragmented balloon (the arrows); **D.** Retrieved distal part of the ruptured balloon and The AndraSnare Micro ASM-4 system. **E.** Final angiography after retrieval of the ruptured balloon. **F.** Intravascular ultrasound of Cx confirming good stent apposition and precluding significant calcifications

A 49-year-old patient was admitted to the cardiology department with a diagnosis of non-ST-segment elevation myocardial infarction (NSTEMI). He was treated for 3 days using aspirational thrombectomy for ischemic stroke. An echocardiogram showed preserved left ventricular ejection fraction with regional hypokinesia of the lateral and posterior wall of the left ventricle. The coronary angiography exhibited a well-organized thrombus in the mid-circumflex artery (mid-Cx) (Figure 1A). Aspirational thrombectomy was performed via the Export Aspiration System (Medtronic, Minneapolis, MN, US) following pre-dilatation with a 3.5 × 20 mm semi-compliant balloon. Despite inflation of the balloon, the optical coherence tomography intravascular probe did not cross the lesion. Based on angiography, a 4.0 × 38 mm drug-eluting stent was implanted. During post-dilatation, a 4.5 × 15 mm non-compliant balloon inflated at 24 atm ruptured and was removed “en-bloc” with a guidewire and guide catheter (Figure 1B). The shaft and the distal end of the ruptured balloon were entrapped in the vessel (Figure 1C). The patient remained hemodynamically stable; therefore, bailout surgery was deferred. The guiding catheter was switched to a 7F system. Attempts of crossing the lesion with Runthrough NS, BMW II and Whisper MS guidewires were unsuccessful. Eventually, the Gaia Second (Asahi Intecc Co., Nagoya, Japan) was delivered into the distal end of the vessel. A 3.0 × 20 mm semi-compliant balloon was inflated to 18 atm, allowing us to cross the defragmented balloon with 4 mm/175 cm AndraSnare Micro ASM-4 (Andramed GmbH, Reutlingen, Germany) and successfully re-

trieve the defragmented balloon (Figure 1E). After removal, the stent was post-dilatated with a 4.0 × 15 non-compliant balloon catheter. Intravascular ultrasound was applied to rule out significant calcifications and confirm the optimal outcome of the procedure (Figure 1F). Post-procedural hospitalization was uneventful, and the patient was discharged 3 days later.
