Fracture of the distal part of an implantable cardioverter-defibrillator lead two months after implantation

Muhammet Dural, Kadir Ugur Mert, Selda Eraslan, Kemal Iskenderov, Yuksel Cavusoglu

Cardiology Department, Eskisehir Osmangazi University, Büyükdere Mahallesi, Eskisehir, Turkey

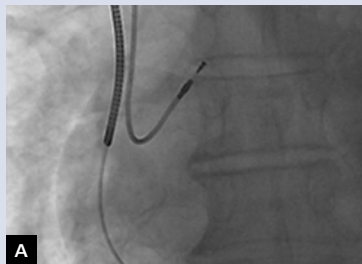
Most lead fractures occur near the subclavian venous entry site due to compression of the lead between the clavicle and the first rib. We present a patient with a distal complete ventricular lead fracture that occurred two months after implantation. A 51-year-old man with ischaemic dilated cardiomyopathy, whose ejection fraction was 21% underwent dual-chamber implantable cardioverter-defibrillator (ICD) implantation (St. Jude Medical, DR 2377-36C ICD) in our centre. The ventricular lead and atrial lead were placed passively by using subclavian vein puncture (Fig. 1A, B). Atrial and ventricular lead impedances were 530 Ω and 740 Ω , respectively. After two months, in routine pacemaker control, the ventricular lead impedance was found to be dramatically increased ($> 3000 \Omega$). Fluoroscopy showed a complete ventricular lead fracture at the distal part of the electrode (Fig. 2A). Then extraction of the fractured lead and insertion a new ventricular lead was planned. Two days later, just before the operation, fluoroscopy showed that the fractured distal part of the lead was embolised to the distal right pulmonary artery (Fig. 2B). The fractured lead was extracted (Fig. 3) and a new ventricular lead was implanted with no complications (Fig. 4). In our patient the fracture occurred a short time after implantation. The patient stated that he used a chainsaw to cut wood about one month after pacemaker implantation. It was thought that this severe physical activity, which could generate intense vibration, could result in lead fracture. Our case documented that fracture may occur in any segment of the lead, so routine pacemaker control should be made carefully. In the presence of any problem that indicates lead fracture, leads must be investigated with fluoroscopy.
