Late outcome of mitral valve replacement with the Cross-Jones prosthesis 36 years after initial surgery

Key words: Cross-Jones mitral valve prosthesis, malfunction

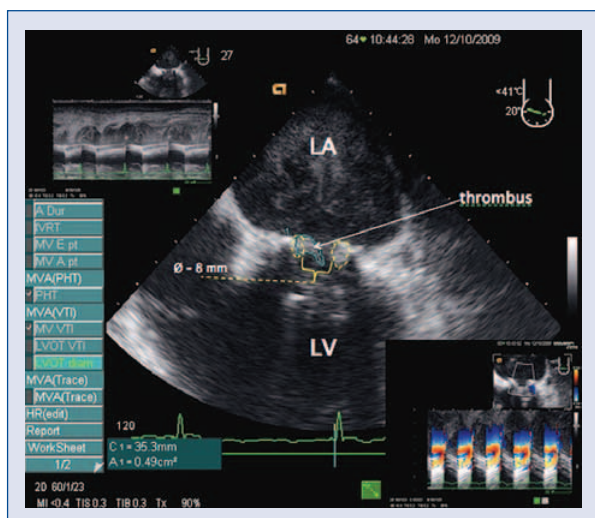
Figure 1. Preoperative transoesophageal echocardiogram with thrombus on the Cross-Jones prosthesis in mitral position and irregular transvalvular flow; LA — left atrial; LV — left ventricle.

Two months later, she was admitted with signs of decompensation in NYHA class IV. A transoesophageal echocardiogram recorded a further malfunction of the prosthesis (Fig. 1) with the elevated transprosthetic gradient of 30 mm Hg, its abnormal movement and periodical out of the transvalvular flow. Additionally mobile thrombi 10–12 mm

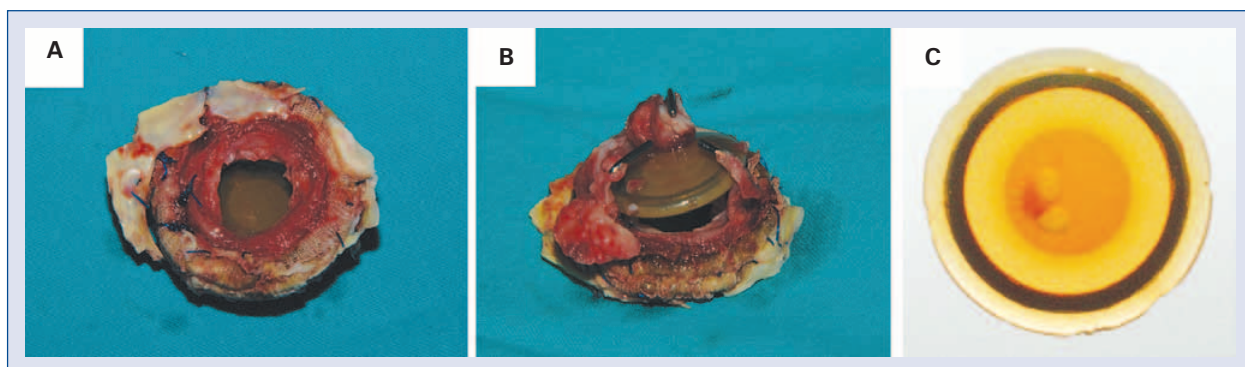
Figure 2. View of thrombotic encapsulation of Cross-Jones prosthesis in mitral position: **A.** From the atrial side; **B.** From the ventricular side; **C.** The damaged disc with irregular rim.

In October 2009, she underwent cardiopulmonary bypass surgery. Cardiac arrest was achieved with antegrade crystalloid cold cardioplegia. From the atrial side, the Cross-Jones prosthesis was nearly totally obscured by the pannus formation and thrombi (Fig. 2A). After removal of the prosthesis, it was revealed that thrombi from the ventricular side restricted the movement of the disc in the prosthetic cage (Fig. 2B). Furthermore, the silicone disc had an irregular rim and was damaged (Fig. 2C). The pannus was maximally excised and the Medtronic prosthesis Advantage 27 was implanted. We used 2–0 interrupted pledgetted sutures, which were introduced from the atrial side towards the ventricle in an inverted ‘U’ fashion. The early post-operative period was without complication. She left hospital on the 21st day after her operation without any signs of decompensation.

We describe the 36 years of working of a mitral Cross-Jones caged disc prosthesis implanted in the mitral position in 1973. The Cross-Jones prosthesis was one of the first with a low profile cage. The silicone disc was elastic, as all silicone details were. This was the cause of many malfunctions of implanted prostheses, so this type of valve was replaced by new one-tilting disc valves. In 1967, the Björk-Shiley valve started the era of tilting disc prostheses [1]. As we know, the history of cardiac valve prostheses began in 1952 with Hufnagel
