# Perforation by permanent pacemaker lead: How late can they occur?

*Perforation by permanent pacemaker lead is rare but does occur. Usually perforations happen soon after the procedure, mostly within one year. But rarely, they occur late. We report a case of delayed perforation by passive fixation lead 33 weeks after the implantation in a patient with no comorbidities. The patient remained asymptomatic regarding the perforation except for having the features of pacing failure. (Cardiol J 2012; 19, 3: 326–327)*

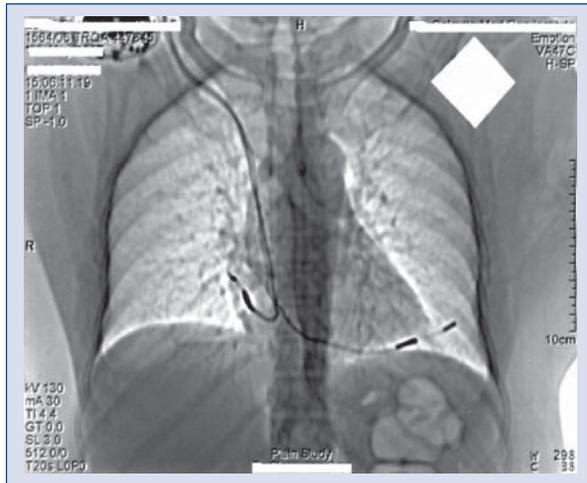
**Figure 1.** Computed tomography scan showing perforated ventricular lead outside cardiac shadow.

A 49 year-old lady presented with exercise intolerance with intermittent episodes of presyncope for three months. She had one episode of syncope also two weeks prior to presentation. She did not have any other comorbidities. Three years ago, she had similar symptoms. She was found to have bifascicular block (RBBB with LAHB) with intermittent third degree atrioventricular block, for which a DDD pacemaker had been implanted in right infraclavicular region at that time. Atrial lead was screw-in lead and ventricular lead was tined in nature. Procedure was uneventful and she was under regular follow-up post-procedure. The last permanent pacemaker (PPM) check-up was done six months prior to presentation. At that time, all the PPM parameters were within acceptable limits. This time, on pacemaker interrogation, it became evident that sensing and pacing parameters of atrial lead were normal, but there was total sensing and capture failure of the ventricular lead. Patient was hemodynamically stable. X-ray chest (PA view) gave rise to suspicion of ventricular lead displacement outside pericardium. Computed tomography-thorax confirmed the lead migration and tip of ventricular lead was found to be much outside the pericardium, within lung parenchyma (Figs. 1, 2). There

was no pericardial effusion or tamponade. So a diagnosis of perforation by PPM lead was made.

As the lead was tined and therefore with bulky tips, and as it had migrated too far, transvenous lead extraction would have been difficult and risky. So, open surgery was chosen to extract the lead. Under general anesthesia, thorax was opened. Lead was easily located inside lung parenchyma and transected. The proximal part of the lead was then pulled transvenously. It came out without any problem. Right ventricle (RV) was repaired under direct vision. A new lead was positioned in RV through subclavian puncture. Patient recovered well. She has been under regular follow-up and without problems for the last two years.

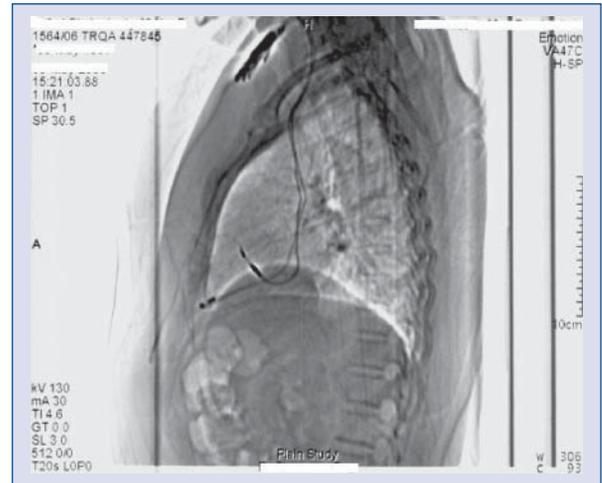
**Figure 2.** Computed tomography scan showing perforated ventricular lead — lateral view.
