Deaths due to hydrogen sulphide on a jack up rig at Bombay High: an avoidable accident

The case report describes an incident on board an oil rig where the rig workers were exposed to noxious gases resulting in multiple fatalities. Work involved gas sampling/monitoring at various locations inside the “spud tanks” of the rig and certifying it free of noxious gases for marine surveyor’s inspection.

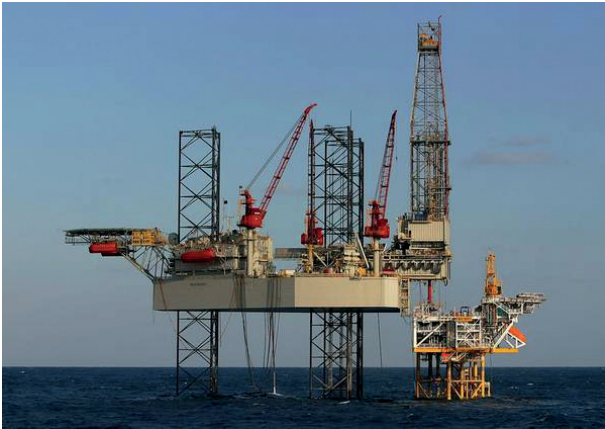
Offshore drilling in depths up to a maximum of 120 m of sea water (msw) is carried out by using a “jack up rig”. They are fitted with long support legs that can be raised or lowered. Bottom of the legs are fitted with base cones, which are approximately 380 m³ in volume and penetrate into the soil to give stability to the rig. They are like the feet of a rig and support the weight of the rig (15,000 tons) (Figs. 1, 2).

Figure 1. Jack up rig

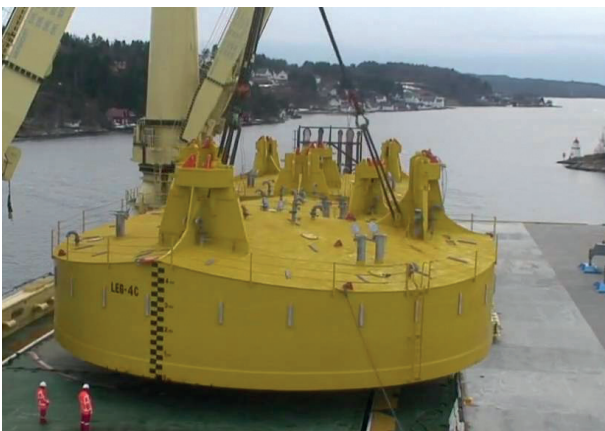
All marine structures have to undergo periodic inspection cycle every 5 years to ensure its efficiency within design parameters, so also spud cans. They are pulled out of water

Figure 2. Spud can removed for maintenance

and undergo external and internal inspection. Unfortunate incident occurred during an inspection of a spud can.

Cause of death as determined by coroner was asphyxia. Circumstantial evidence pointed to inhalation of H_2S that was anticipated in the spud can. Spud can is almost 5 m in height and because of its typical internal construction, has numerous nooks and corners which are not well ventilated. In addition, there were puddles of mud sludge which contain dissolved H_2S . First person who went inside the spud can dislodged the collected H_2S in low areas and also the sludge containing dissolved H_2S . Being exposed to this, he became unconscious and collapsed. Access to a spud can is very small and exhaust of continuous ventilation could escape to atmosphere through this single opening only. Attendant who was at the bottom of the ladder was thus affected by the toxic gas evolved and collapsed. Supervisor entered the spud can without a breathing apparatus and was affected by H_2S . “Stand by” person was affected by the gush of gas coming out of the opening due to forced ventilation but being in the open, quantity of gas inhaled was much less and could be revived.
