Supplementary material

Krawczyk-Ozóg A, Chyrchel B, Hołda MK, et al. Biannular atrioventricular valve disjunction as a potential cause of ventricular remodeling and subsequent cardiac arrest. Pol Heart J. 2024.

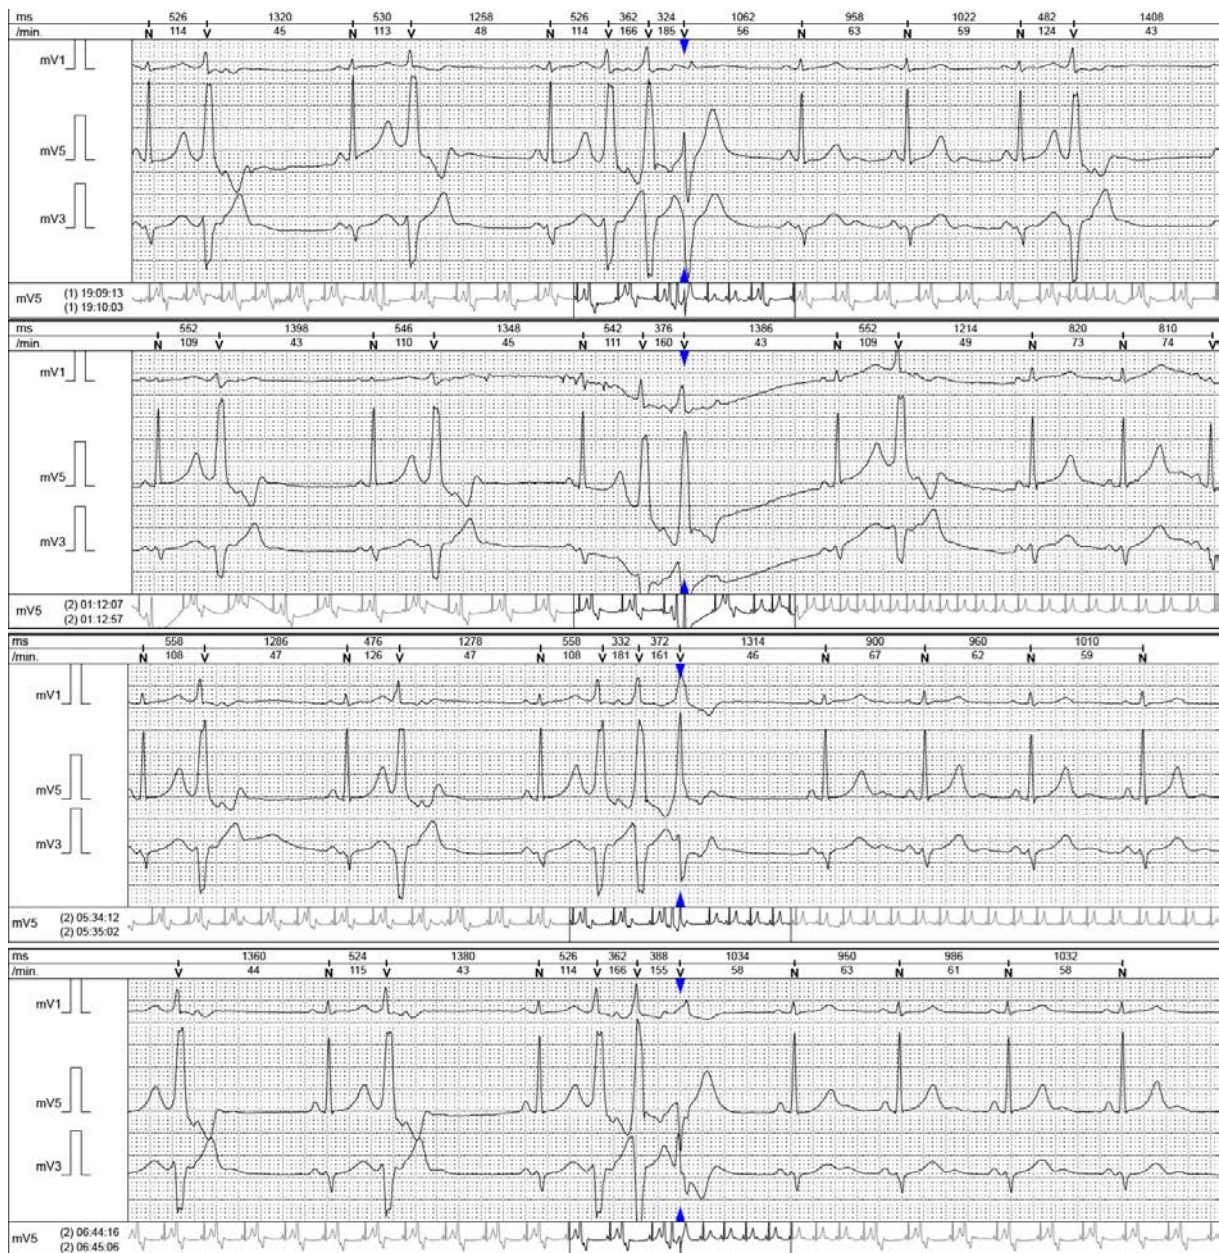
Figure S1. Holter electrocardiogram recording showing complex ventricular ectopy
